A Multi-Scale Approach to Assess and Restore Ecosystems in a Watershed Context

Ronald D. Smith and Charles V. Klimas

September 2013

Final report

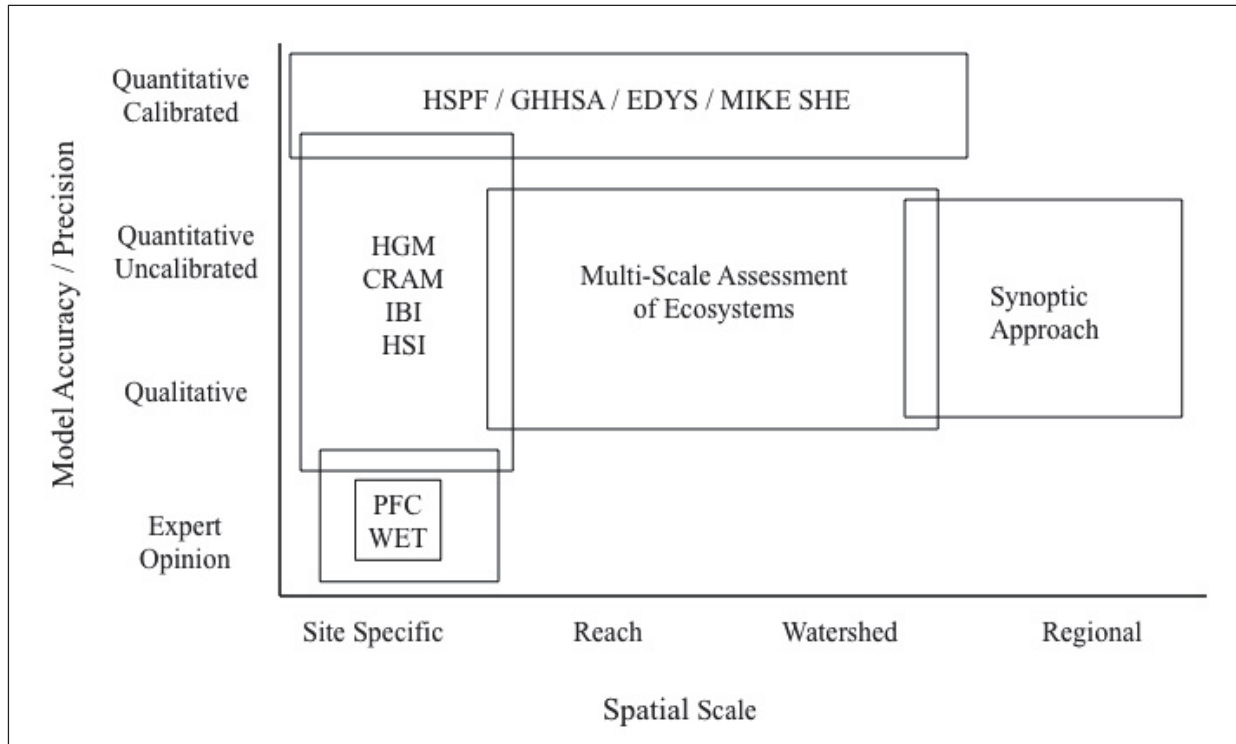
Figure 1. Ordination of assessment methods based on spatial scale and model accuracy/precision.

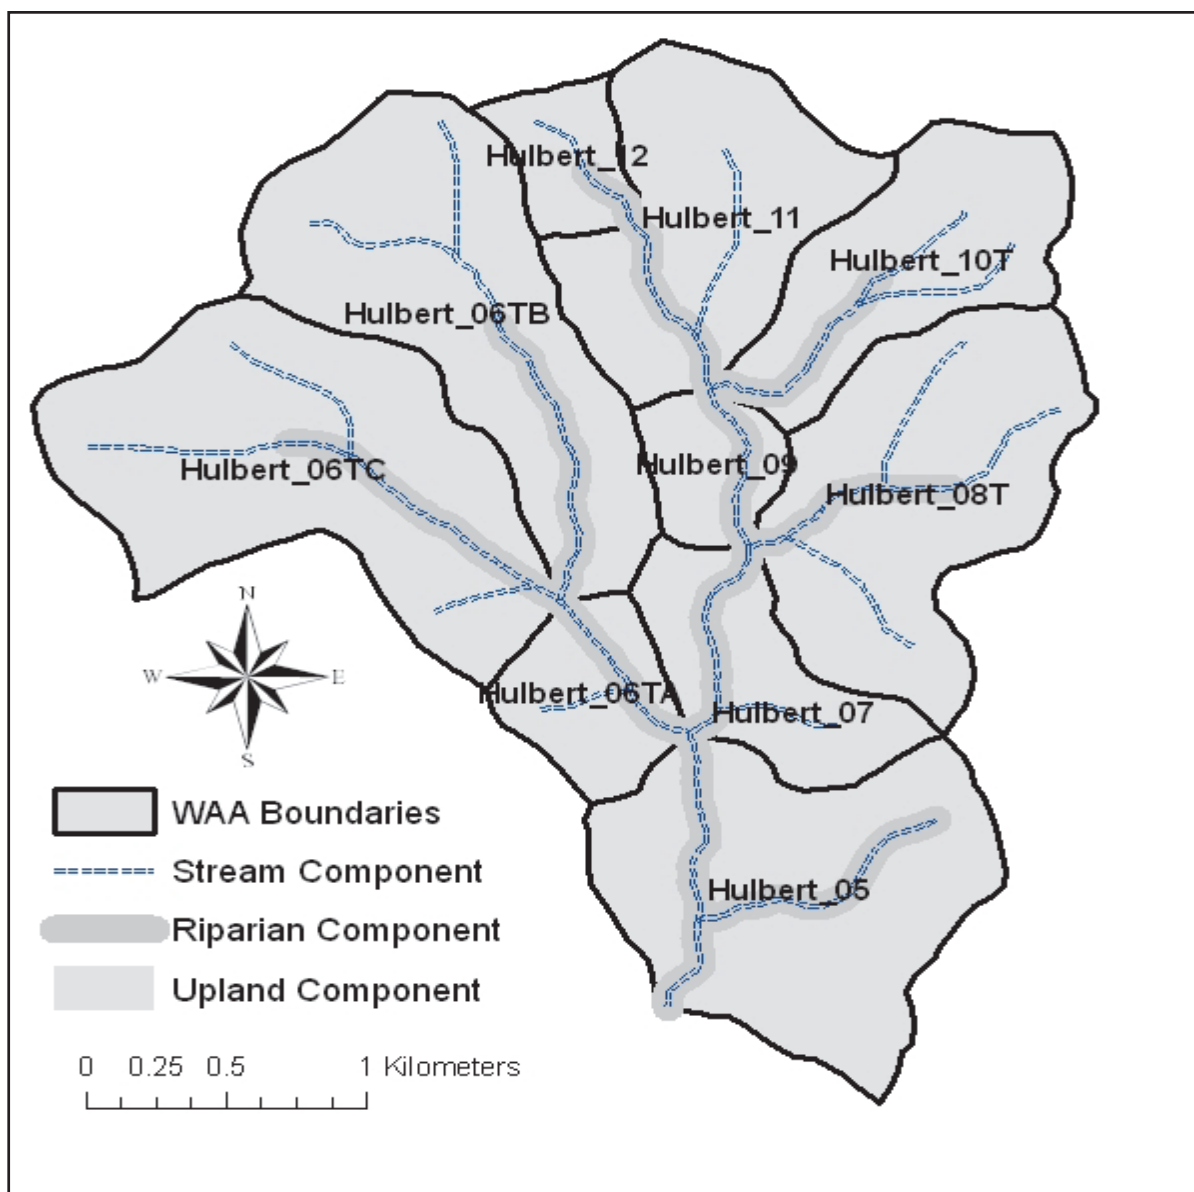
Figure 3. Watershed Assessment Areas, local drainages, drainage basins, and stream, riparian, and upland components of the WAA.

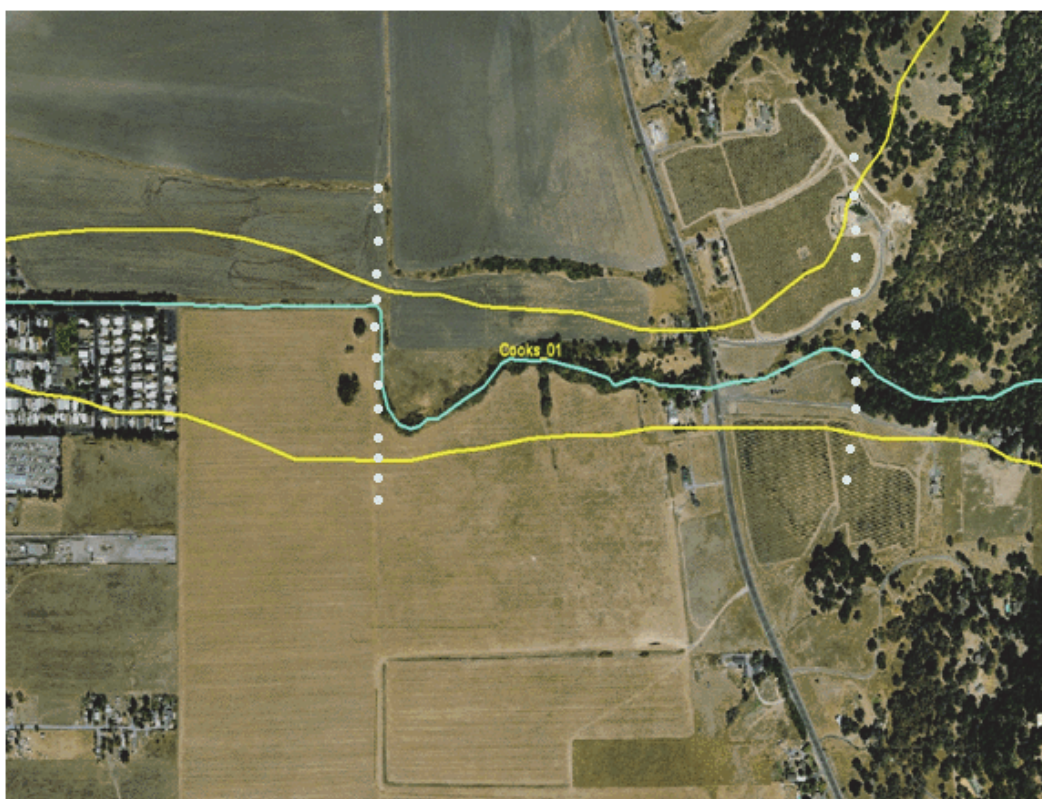
Figure 4. WAA upstream and downstream boundaries (dotted lines) drawn at changes in land use.

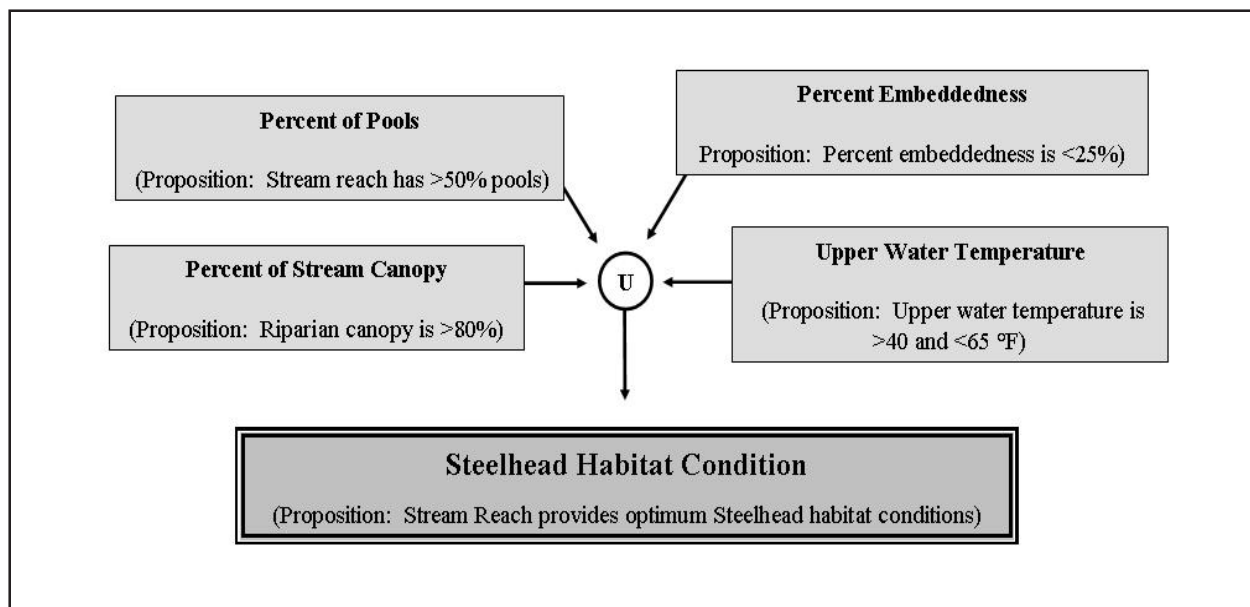
Figure 5. Knowledge base schematic for the Steelhead Habitat Condition ranking criterion.

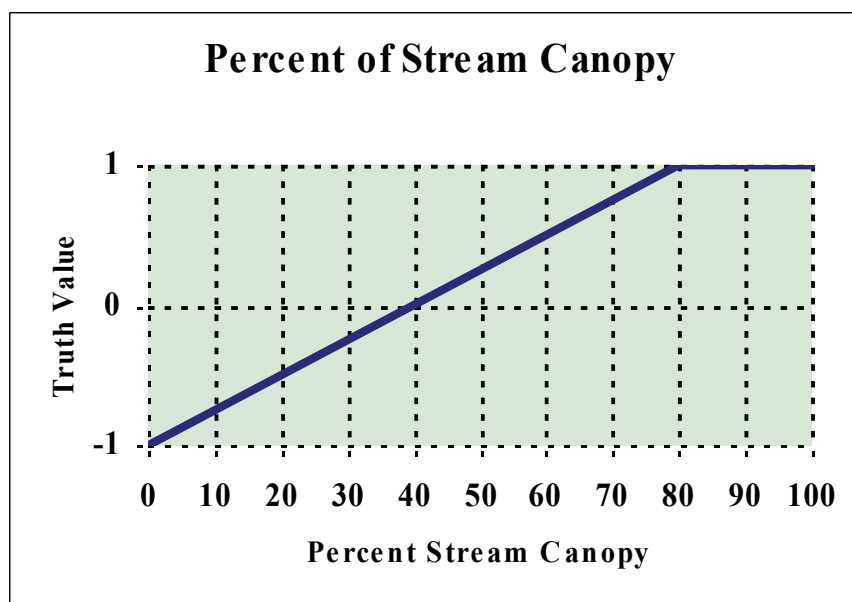
Figure 6 shows the relationship between the Percent of Stream Canopy indicator and the truth-value. If the Percent of Stream Canopy is $\geq 80\%$, a truth-value of "1" (i.e., totally true) is assigned. If the Percent of Stream Canopy is 0%, a truth-value of "-1" (i.e., totally false) is assigned. If the Percent of Stream Canopy is between 0% and 80%, a truth-value between "1" and "-1" is assigned based on fuzzy logic. Fuzzy logic makes it possible to incorporate "partial truth," as opposed to classical Boolean logic, where things are either totally true or totally false.

Figure 6. Relationship between the Percent Canopy Cover indicator and truth-value.

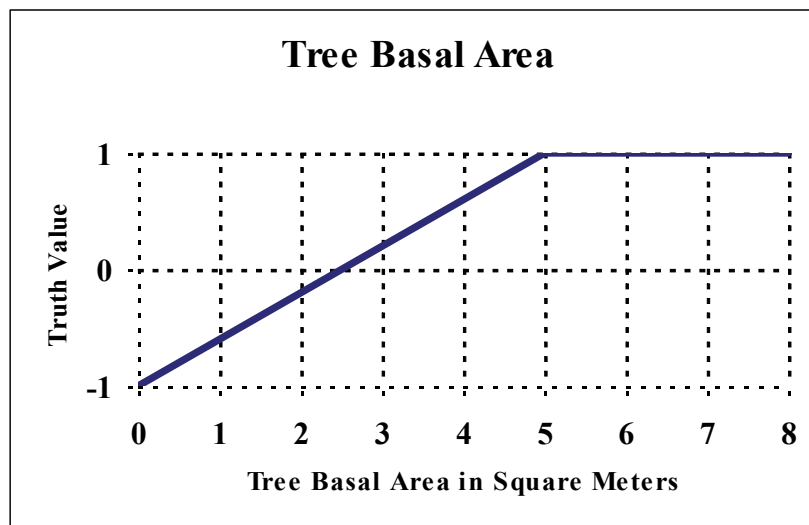
which an indicator is assigned either a totally true or totally false truth-value. For example, in Figure 7 the totally true breakpoint for “large” trees is defined at a basal area of 5.0 m². Any tree with a basal area ≥ 5.0 m² is assigned a truth-value of “1.” The totally false breakpoint for “large” trees is defined at a basal area of 0.1 m². Any tree with a basal area ≤ 0.1 m² is assigned a truth-value of “-1.” For trees with a basal area between 0.1 m² and 5.0 m², an intermediate truth-value is assigned to reflect its degree of largeness. For example, a tree with a basal area of 4.0 m² is assigned a truth-value of “0.8,” and a tree with a basal area of 1.0 m² is assigned a truth-value of “-0.75,” and so forth.

Figure 7. Relationship between Tree Basal Area indicator and truth-value.

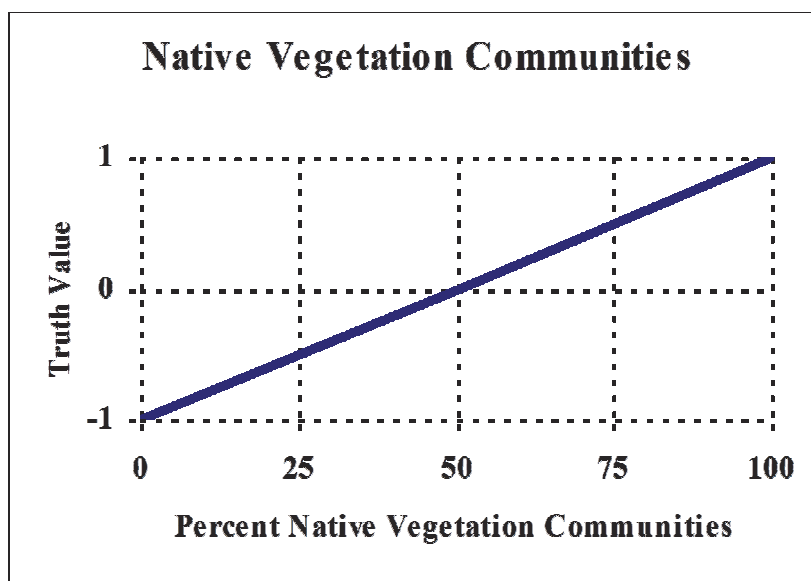
Figure 8. Relationships between indicators and truth-values for the Native Vegetation Community indicator.

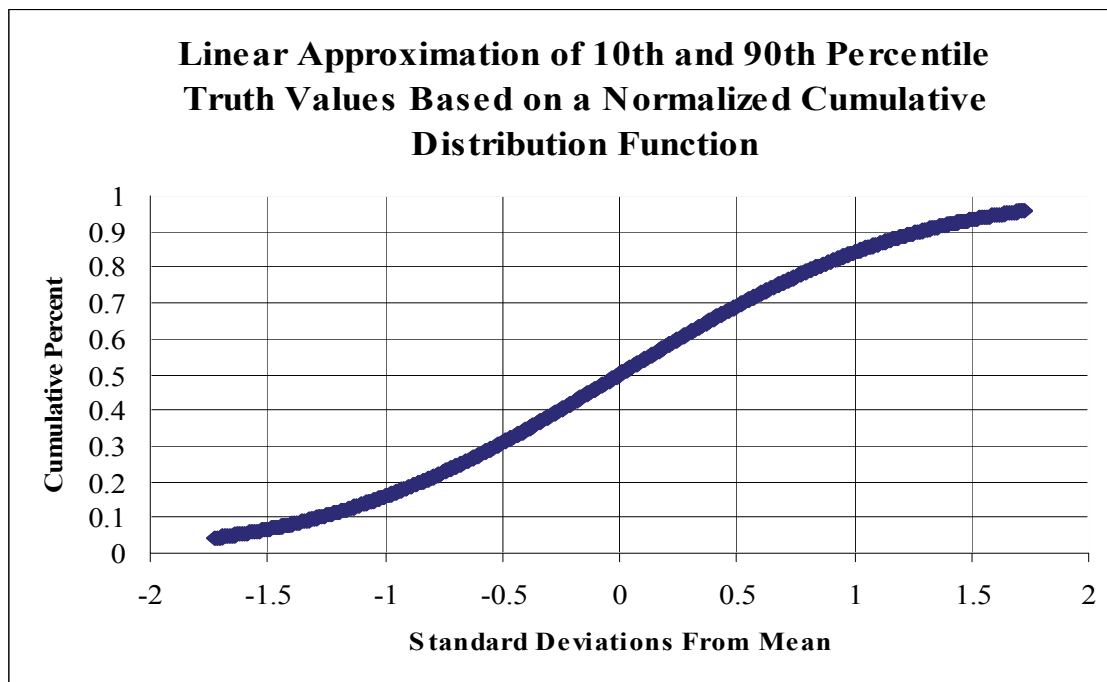
For some indicators there are no field data, literature values, expert opinion, or intuitive bases for defining the relationship between an indicator and truth-values. In these situations, an empirical approach is used to establish the relationship. Conceptually, this involves using the range of indicator values from WAAs across the watershed and setting the totally true breakpoint slightly below the maximum indicator value, and the totally false breakpoint slightly below the minimum indicator value. Specifically, this was accomplished by calculating the mean and standard deviation of all indicator values and using the 10th and 90th percentiles of the linear approximation of the normalized cumulative distribution function as the totally false ("-1") and totally true ("1") truth-value breakpoints, respectively (Figure 9). While not valid outside the context of the project watershed, this approach provides reproducible, relative relationships between indicator values and truth-values for indicators that lack the information to establish a relationship between an indicator and truth-value. As with the previously described index model method, a variety of ecosystem assessment indices can be generated using this knowledge base approach.

Figure 9. Normalized cumulative distribution function with linear approximation of 10th and 90th percentiles.

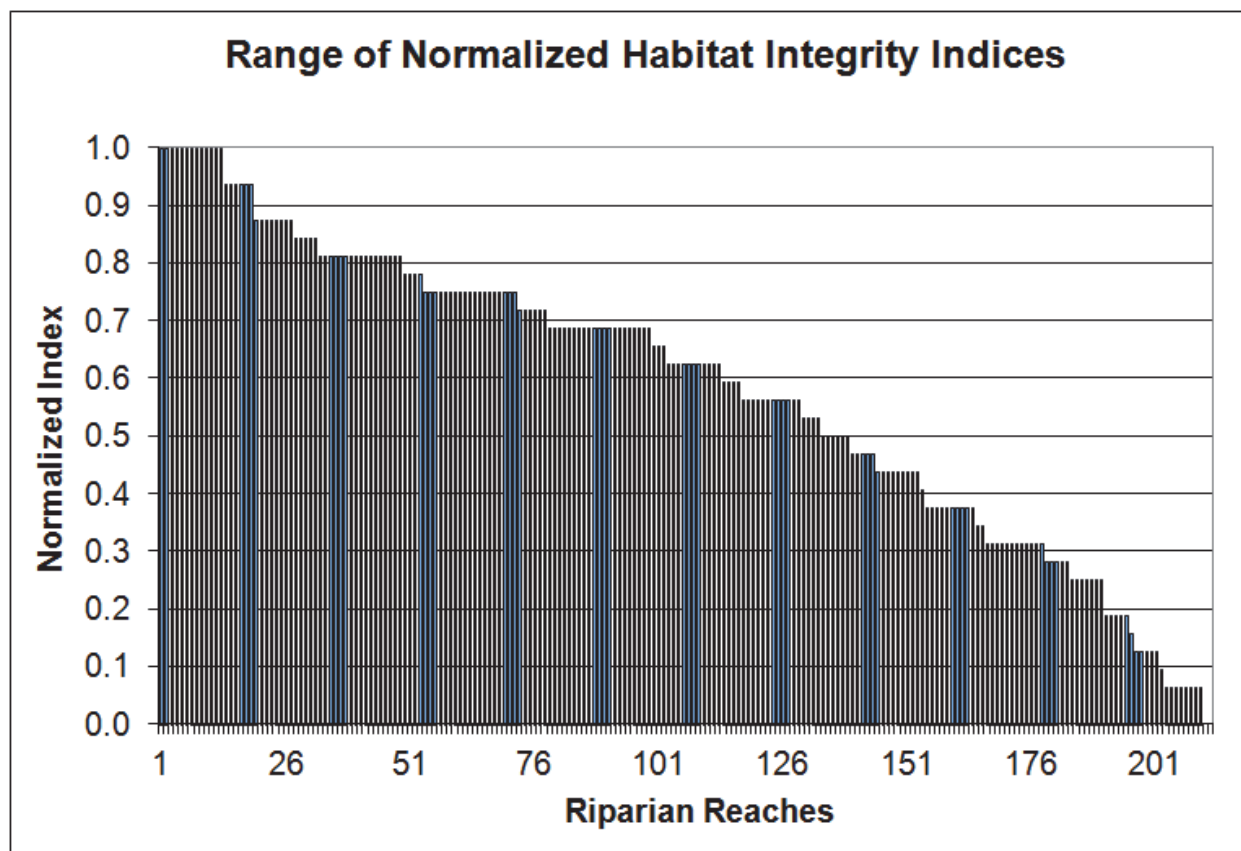
Figure 11. Summary of normalized indices of habitat integrity.

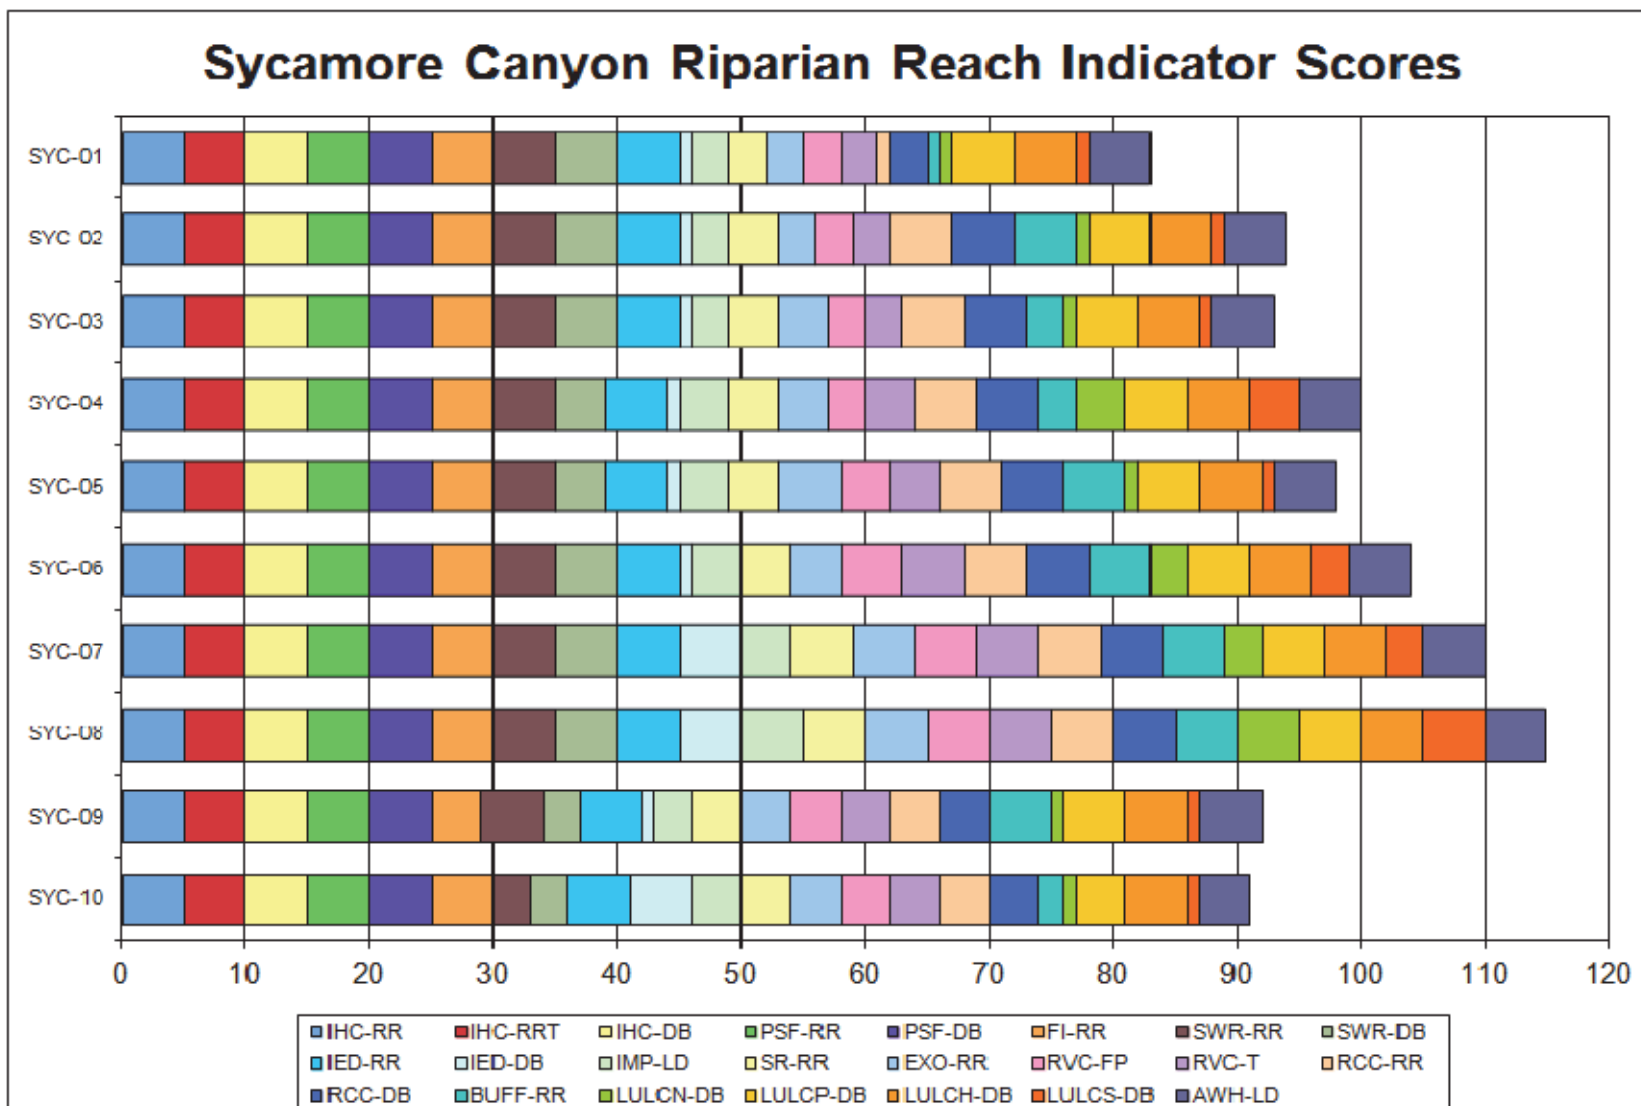
Another way to present the results is shown in Figure 12. This figure shows indicator scores for a series of WAAs moving from the bottom to the top of a large canyon. This type of display is often useful in interpreting results. For example, it can be seen in general that the condition of riparian ecosystems degrades from the top to the bottom of the canyon, with the exception of the SYC-09 and SYC-10 WAAs. The SYC-09 and SYC-10 WAAs have a lower index because the land use in the drainage basin is agricultural, which results in a low score for the LULCCN-DB (#19 increased nutrients) and LULCS-DB (#23 increased sediments) indicators, as well as the SWR-DB (#8 surface water retention in impoundments) indicator. Also, a series of narrow bars near the middle of the figure represent the IED-DB (#10 import, export, or diversion of surface water) indicator. This signifies that the hydrologic regimes in the SYC-01 through SYC-06 WAAs are significantly affected by an alteration to the flow regime. This alteration is a result of an import or export of surface water that occurs in SYC-09 WAA, which is immediately upstream of SYC-06, because the main stem channels of the SYC-09 and SYC-07 WAAs join at the upstream boundary of the SYC-06 WAA.

Figure 12. Indicator scores for Sycamore Canyon riparian reaches.

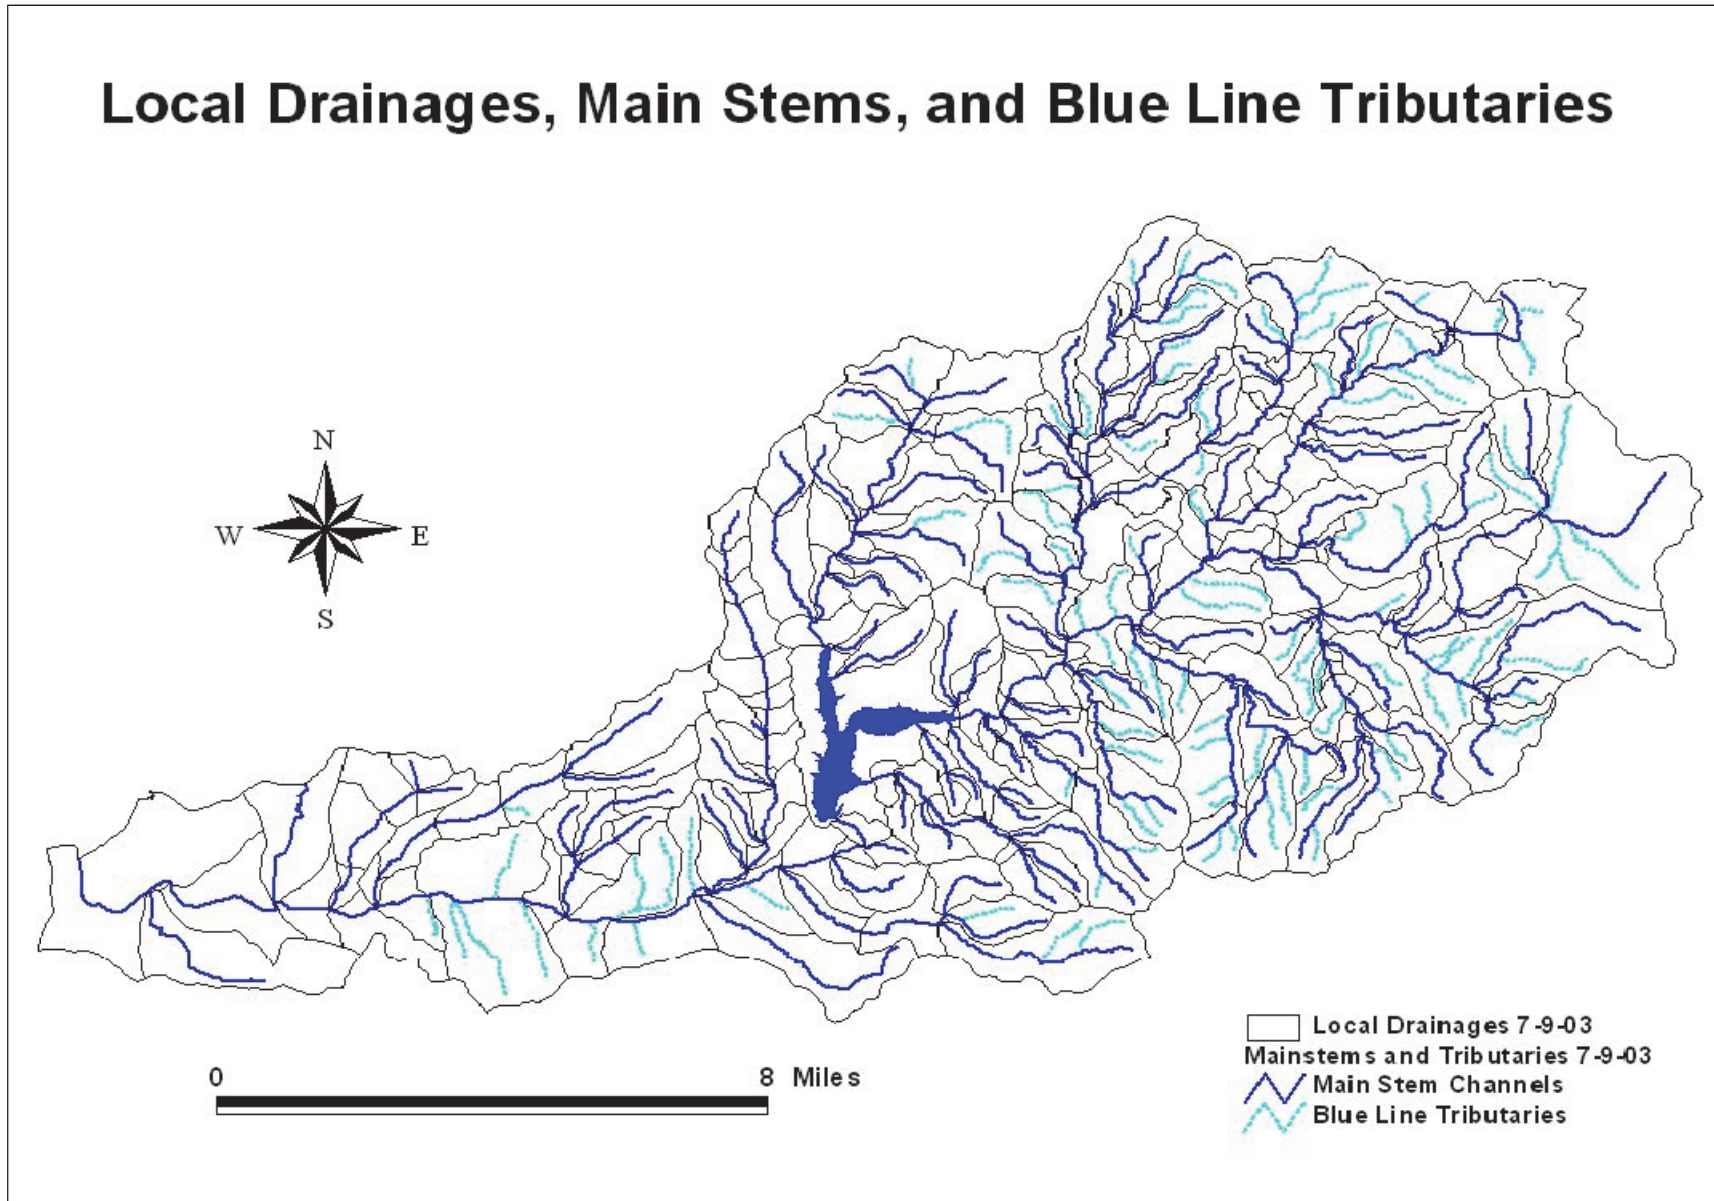
Another useful way to display results of the baseline assessment is through watershed maps developed in a GIS environment. For example, Figure 13 illustrates the main stem channels, tributaries, and local drainage boundary for each WAA in the Otay River watershed. Figure 14 summarizes the Habitat Integrity Index ranking criteria for each WAA in the watershed. The darker green WAA polygons are those with a high Habitat Integrity Index, while the lighter green WAA polygons are those with a low Habitat Integrity Index. The pattern displayed is a common and easily interpreted one: the value of the index is low in areas of urban development, rural development, and agriculture, and higher in the more remote, undeveloped mountainous areas of the watershed.

Figure 13. Otay River watershed showing WAA local drainage boundaries, main stem channels, and tributaries.

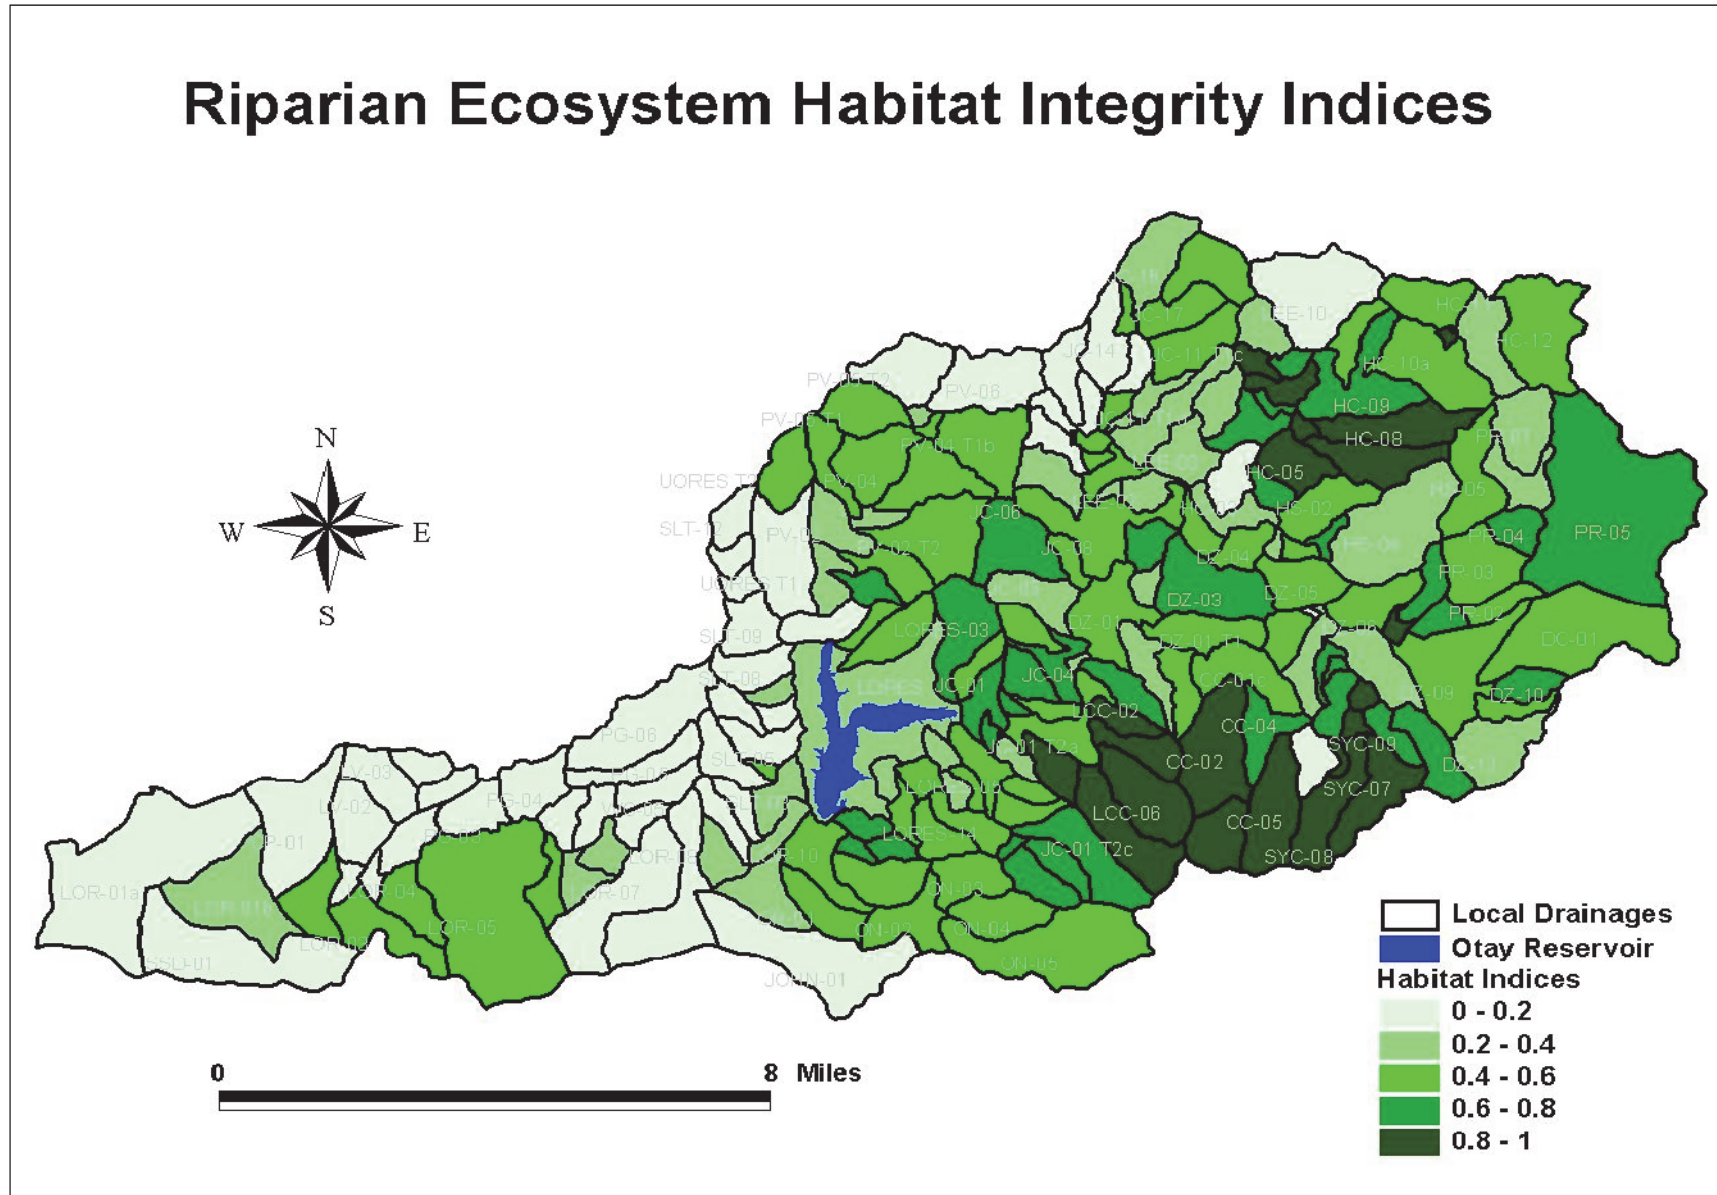
Figure 14. Habitat integrity indices for riparian reaches extrapolated WAAs for display purposes.

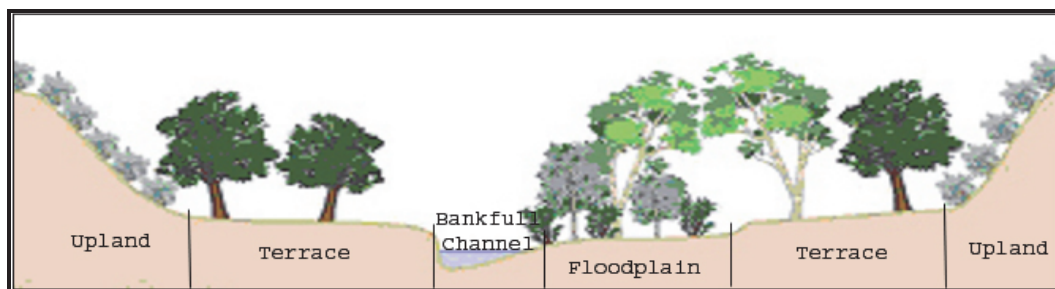
Figure A2. Generalized cross section of a riparian ecotone.

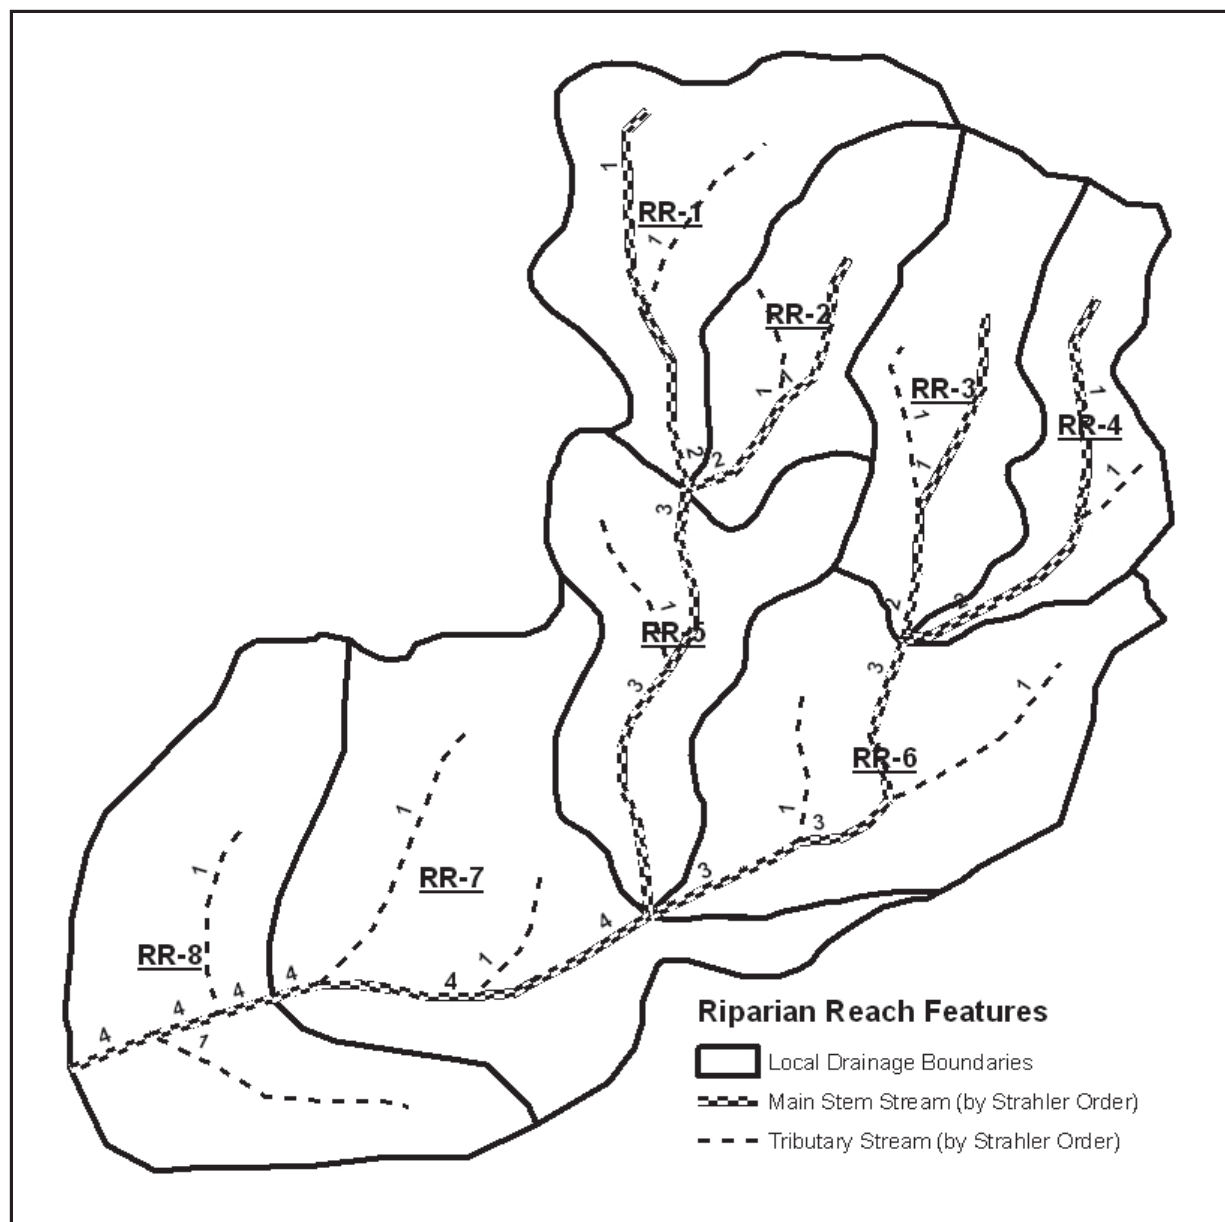
Figure A3. Schematic of riparian reach features.

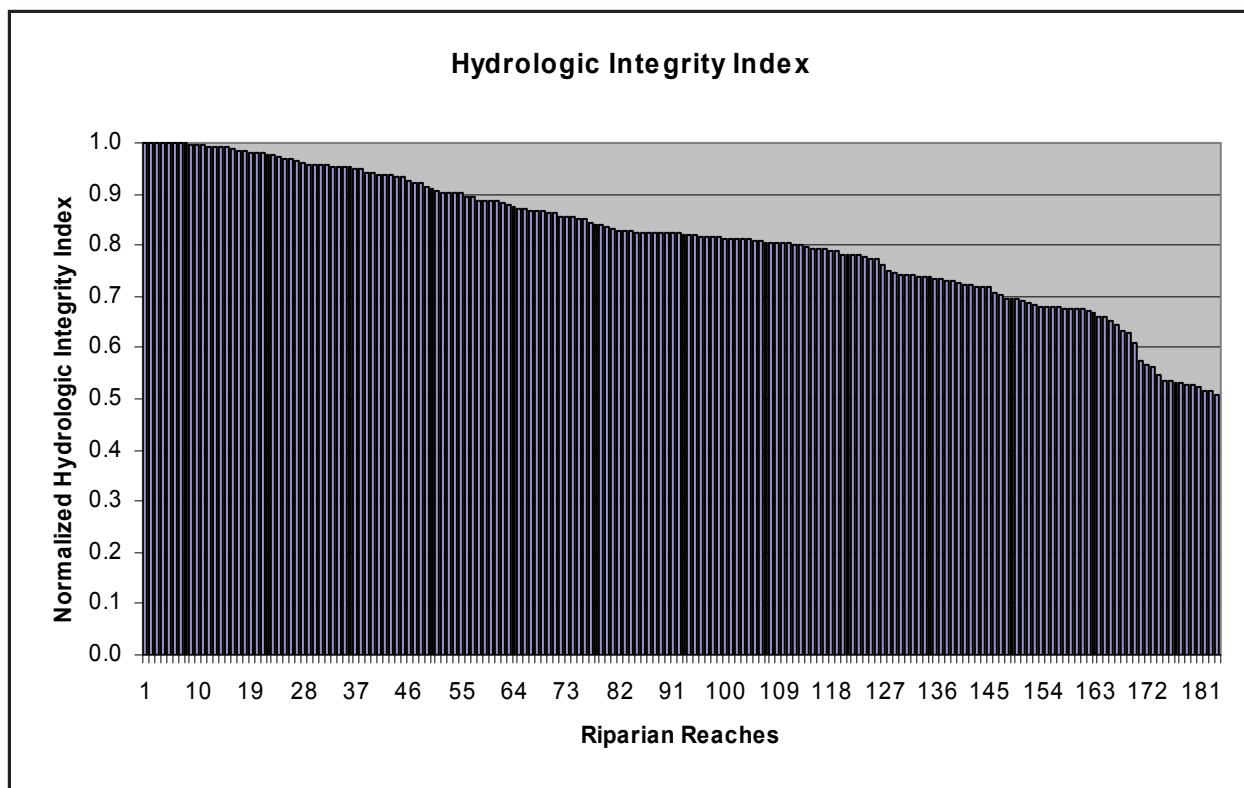
Figure A9. Range of normalized Hydrologic Integrity Indices for riparian reaches.

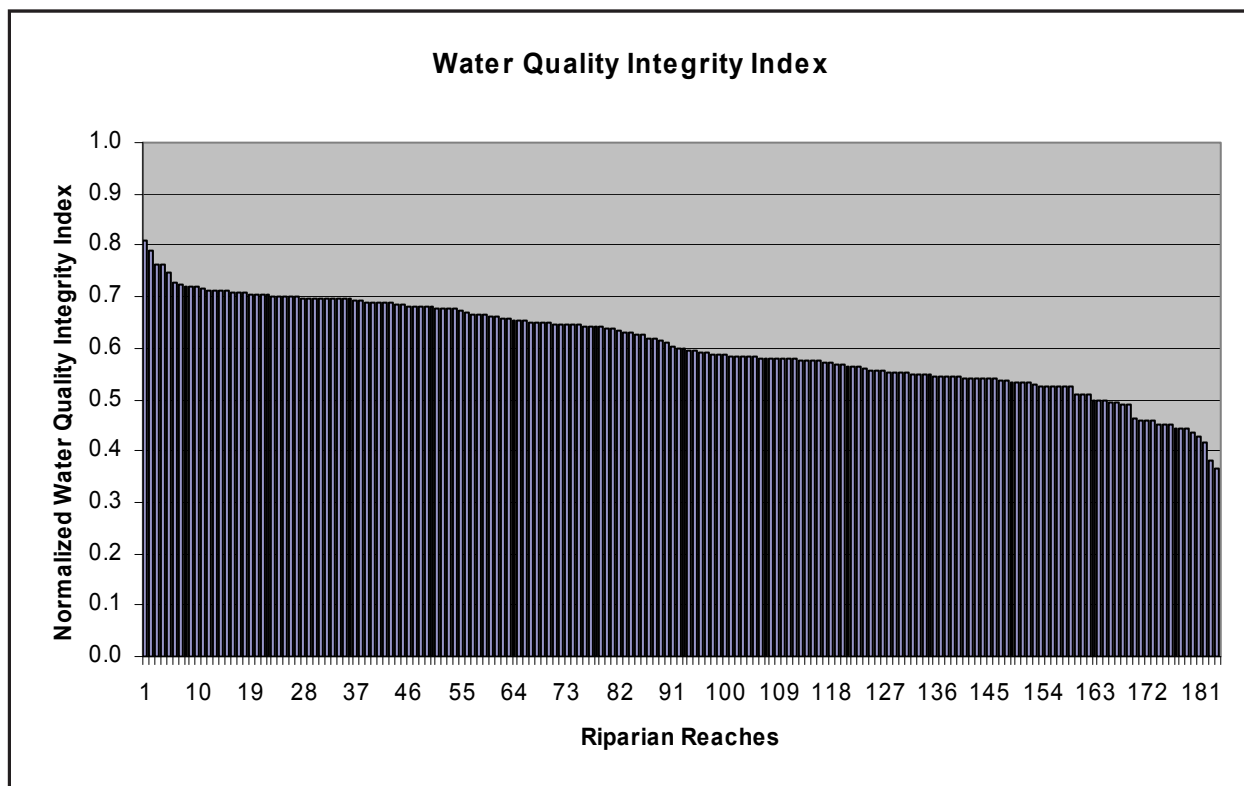
Figure A10. Range of normalized Water Quality Integrity Indices for riparian reaches.

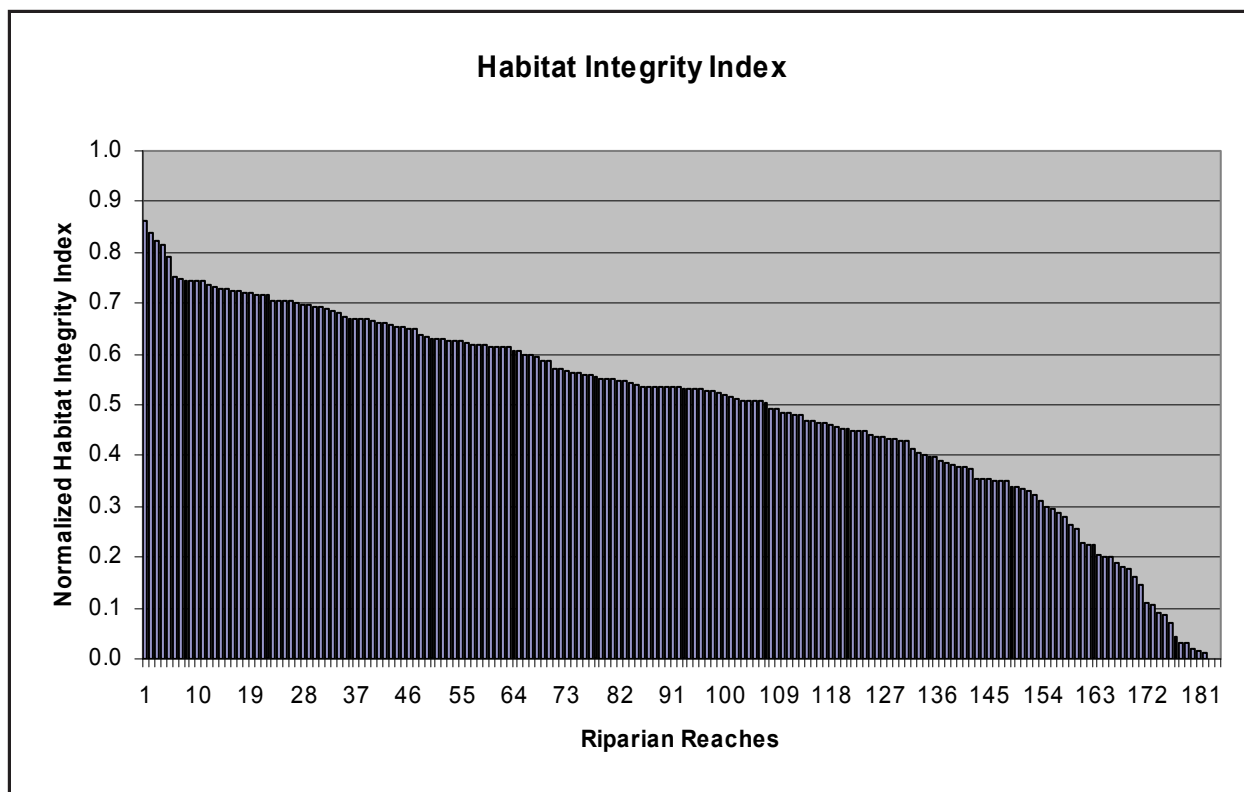
Figure A11. Range of normalized Habitat Integrity Indices for riparian reaches.

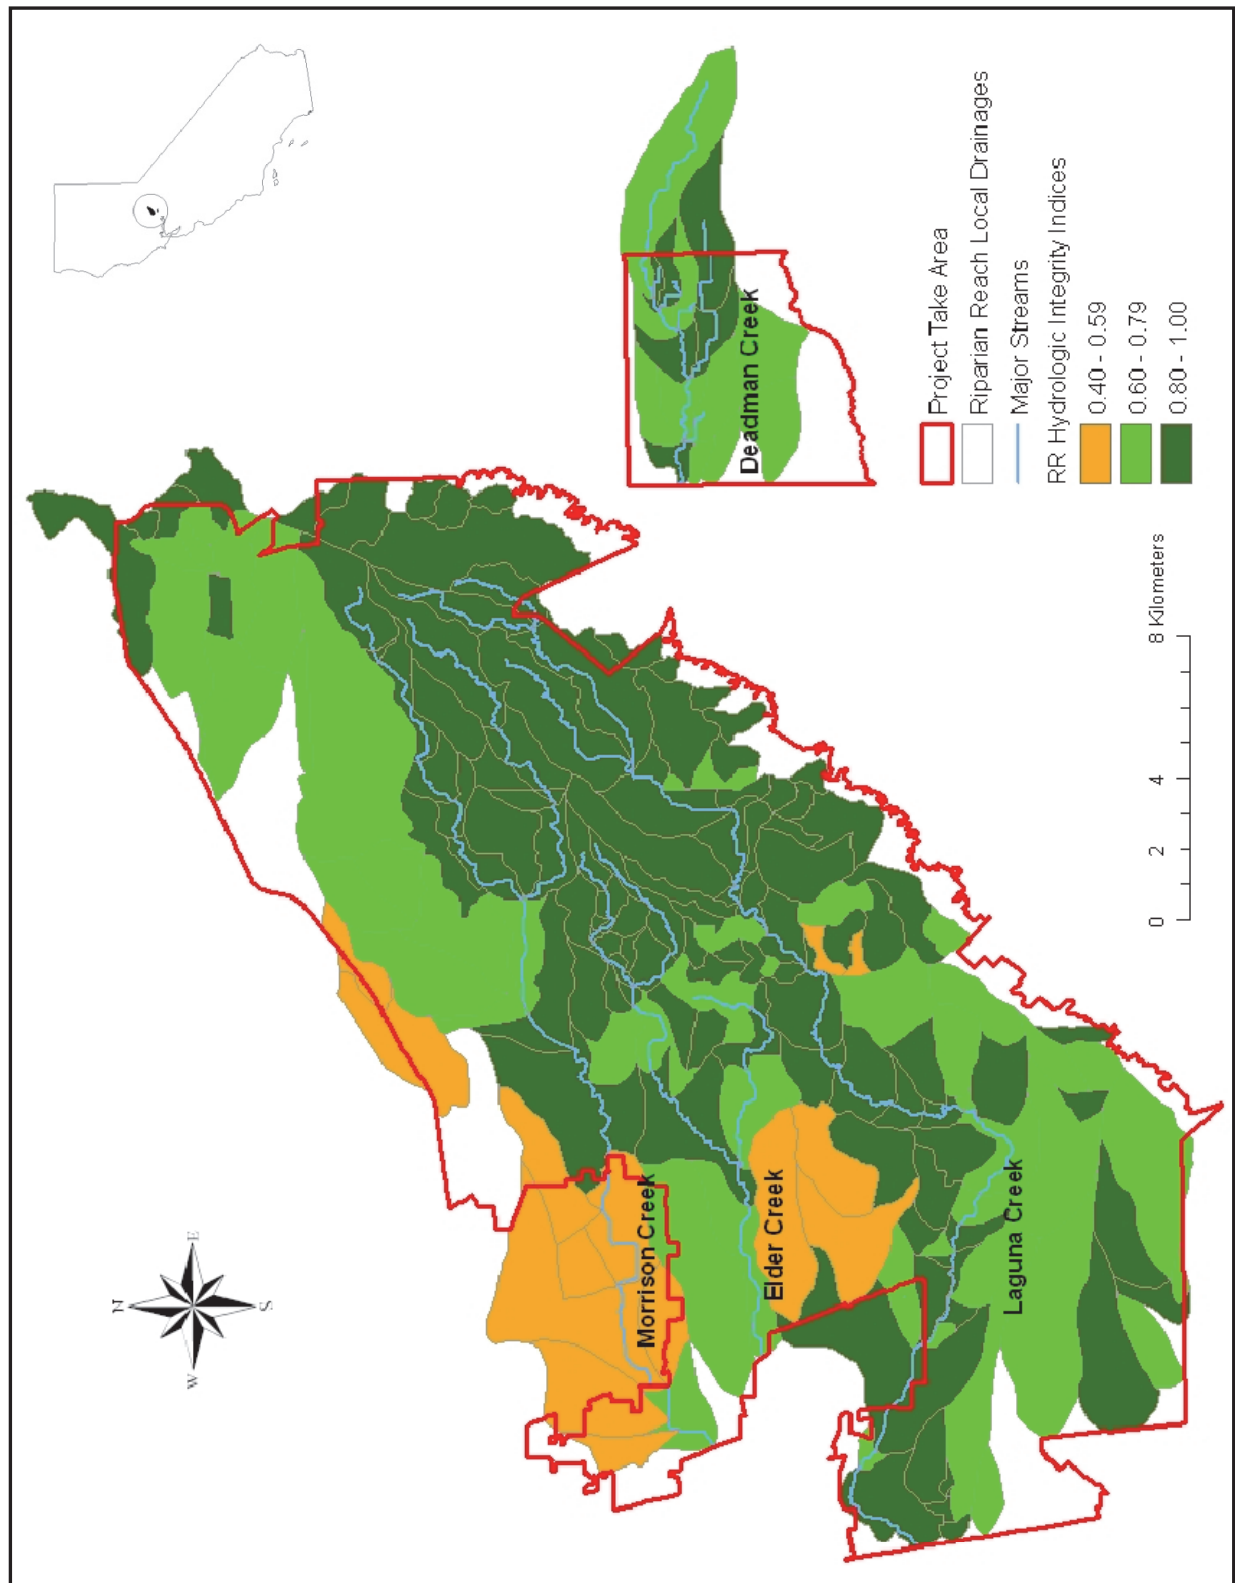
Figure A12. Hydrologic Integrity Indices for riparian reaches in the project take area.

normalized Hydrologic Integrity Index between 0.4 and 0.6. These riparian reaches are impacted by urbanization, which tends to reduce the indicator metric values for the Altered Hydraulic Conveyance, Modified Stream Flow, Stream Floodplain Interaction, and Sediment Regime at the riparian reach spatial scale and Surface Water Detention at the local drainage and drainage basin spatial scales.

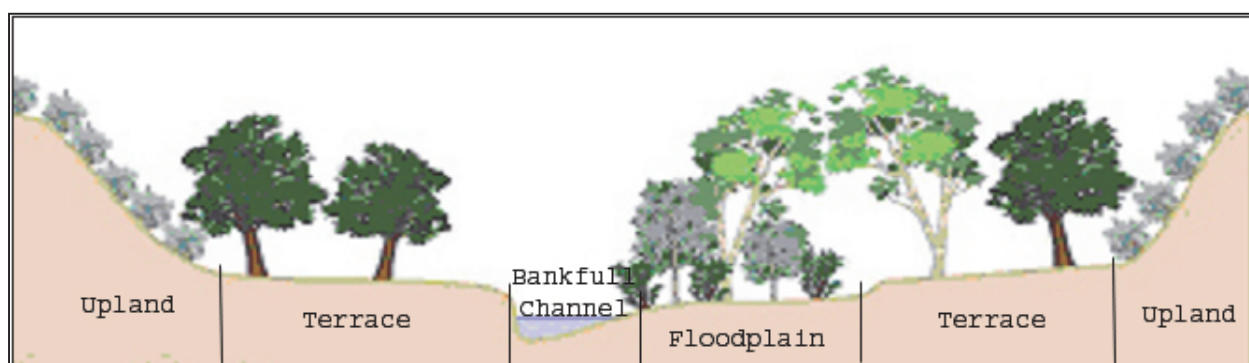
Figure C3. Riparian ecosystem geomorphic surfaces.

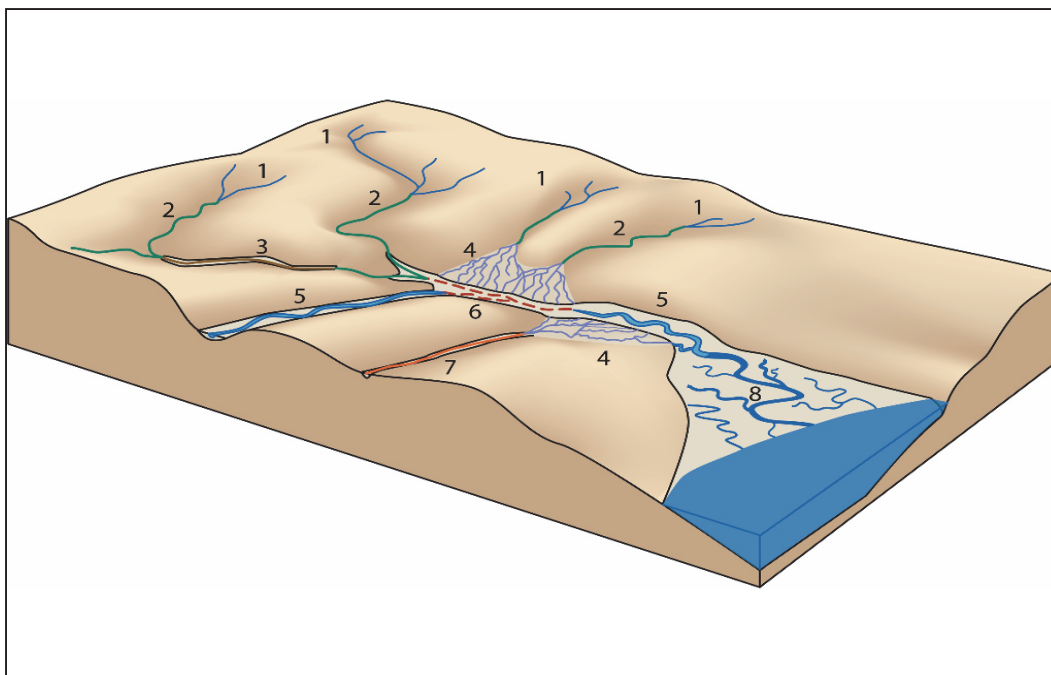
Figure C4. Generalized representation of landscape settings associated with geomorphic zones.
